**Flood Control Project Maintenance  
Levee Inspections**

**Fall 2018 Levee Maintenance Deficiency Summary Report**

**Sacramento River Basin**

**Flood Control Project Maintenance  
Levee Inspections****LMA District Cover Sheet****Fall 2018 Levee Inspection Results****Reclamation District No. 0003 Grand Island**

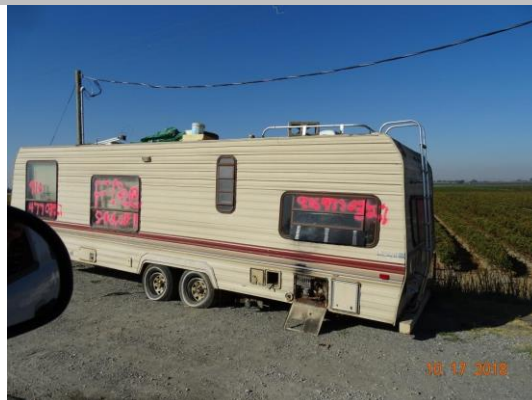
Photo 1 of 1 : FA\_2018\_RD0003\_25\_197\_20181018\_00298.jpg

LM Start	8.04	Rating **	M	Issue No.	197
LM End	8.04	Issue Type +	En	Location *	CR
Category	Earthen Levee			GPS Latitude/Longitude	
				Start	End
Item	Encroachments			38.223160 °	38.223160 °
				-121.557437 °	-121.557437 °
DWR ID	DWR_RD0003_02_f _ 2018_197				
Comment Code					
AV : Abandoned vehicles					
Inspector Comment					
Abandoned trailer should be removed.

View of trailer on the crown of the levee (October 2018).

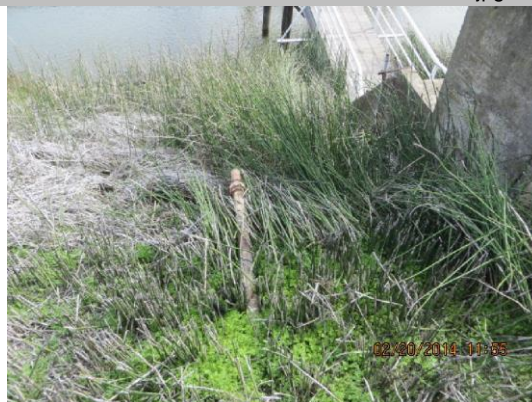
Photo 1 of 1 : UCIP\_FA\_2018\_30588\_56377.jpg

Comment Code					
Inspector Comment					
FS_ID:30588					
DS_ID:22254					
EP_NO: 9436					
Repair Type: Non-Urgent					
Crossing Status: Found					
UCIP Comments: Pipe appears abandoned and if so should be done so properly.					
FIELD_STRUCT_DESC: 2-inch steel water line through the levee, 6.5 feet below the crown. (Retention of a 2-inch steel pipe water line through the levee above the floodplain authorized under Automatic Board Order (ABO) issued as Permit No. 9436, 1974 - Harry A. Sergeant. Plans to construct a floating dock with a walkway on the levee and revive use of an existing reinforced concrete tunnel through the levee authorized under Permit No. 8612, 1974 - Harry A. and Jennie E. Sergeant). [Additional Reference(s): DWR Levee Log, 1993].					
FS Date: 2/20/2014

Pipe visible next to concrete culvert on WS slope.

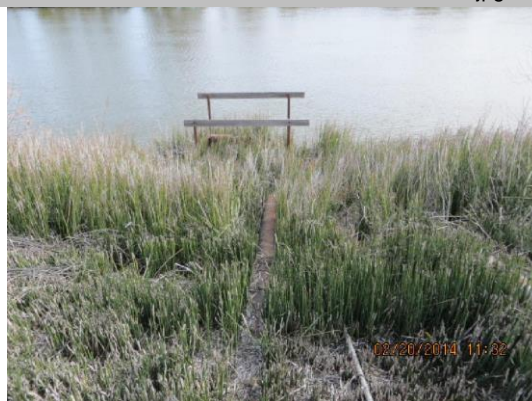
Photo 1 of 3 : UCIP\_FA\_2018\_53485\_56371.jpg

Comment Code						
Inspector Comment						
FS_ID:53485 DS_ID:22256 EP_NO: N/A Repair Type: Urgent Crossing Status: Found UCIP Comments: 07/20/2018 Everything appears to be the same as last time. No changes have been made. Crossing remains "Urgent" due to the erosion present on the LS. (A. McDonald - DWR UCIP)07/06/2016 Pipe is open on WS slope. Same as last inspection. (DWR UCIP - K. Fazel)02/20/2014 Appears abandoned and if so should be done properly. Large erosion holes in 2 places on LS toe due to irrigation flows. (DWR FPIIB - G. Wylie) FIELD_STRUCT_DESC: *ABANDONED* 12-inch steel irrigation discharge pipe through the levee, invert elevation 4.8 feet below the crown. Pump on the waterside (WS) slope. 1.5-inch steel electrical conduit through the levee at the same location. 5-foot by 5-foot concrete distribution box at the landside (LS) toe. [Additional Reference(s): DWR Levee Log, 1993, 10-inch pipe referenced. USACE Sacramento O&M Manual 104, February 1960, (RM 23.20), 10-inch pipe referenced]. Levee Log incorrectly references Gemignani as the owner of this pipe. FS Date: 7/20/2018

Pipe and slant pump visible on WS slope.

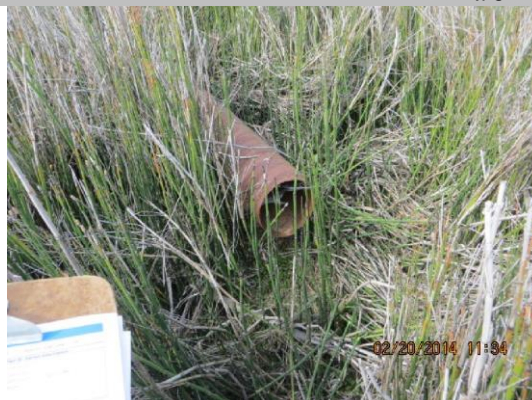
Photo 2 of 3 : UCIP\_FA\_2018\_53485\_56370.jpg

Open pipe visible on WS slope.

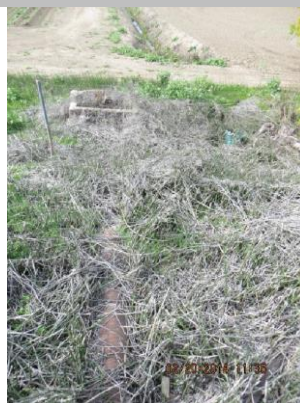
Photo 3 of 3 : UCIP\_FA\_2018\_53485\_56374.jpg

Comment Code						
Inspector Comment						
FS_ID:53485 DS_ID:22256 EP_NO: N/A Repair Type: Urgent Crossing Status: Found UCIP Comments: 07/20/2018 Everything appears to be the same as last time. No changes have been made. Crossing remains "Urgent" due to the erosion present on the LS. (A. McDonald - DWR UCIP)07/06/2016 Pipe is open on WS slope. Same as last inspection. (DWR UCIP - K. Fazel)02/20/2014 Appears abandoned and if so should be done properly. Large erosion holes in 2 places on LS toe due to irrigation flows. (DWR FPIIB - G. Wylie) FIELD_STRUCT_DESC: *ABANDONED* 12-inch steel irrigation discharge pipe through the levee, invert elevation 4.8 feet below the crown. Pump on the waterside (WS) slope. 1.5-inch steel electrical conduit through the levee at the same location. 5-foot by 5-foot concrete distribution box at the landside (LS) toe. [Additional Reference(s): DWR Levee Log, 1993, 10-inch pipe referenced. USACE Sacramento O&M Manual 104, February 1960, (RM 23.20), 10-inch pipe referenced]. Levee Log incorrectly references Gemignani as the owner of this pipe. FS Date: 7/20/2018

Pipe and concrete distribution box visible on LS slope.

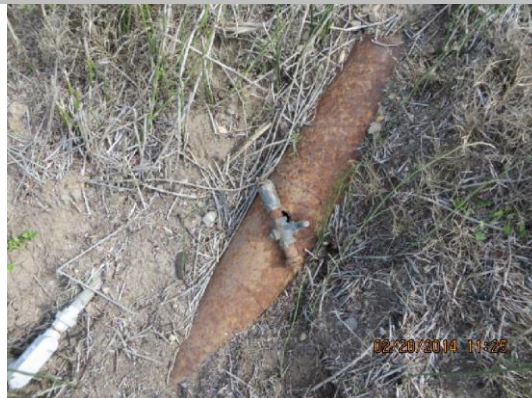
Photo 1 of 3 : UCIP\_FA\_2018\_30577\_56345.jpg

Comment Code						
Inspector Comment						
FS_ID:30577						
DS_ID:22257						
EP_NO: 3593						
Repair Type: Non-Urgent						
Crossing Status: Found						
UCIP Comments: Siphon breaker broken off pipe on LS slope.						
FIELD_STRUCT_DESC: 12-inch coated steel irrigation discharge pipe through the levee, 4 feet below the crown. Pump on a concrete pad on the waterside (WS) slope. 42-inch concrete standpipe at the landside (LS) toe. Siphon breaker on the LS slope. Project drawings included with permit. 1-inch electrical conduit through the levee at the same location. (Plans for construction of a pumping plant on the WS authorized under Permit No. 3593, 1961 - Nelson Dean). [Additional Reference(s): DWR Levee Log, 1993].						
FS Date: 2/20/2014

Siphon breaker/vent broken off pipe at LS slope.

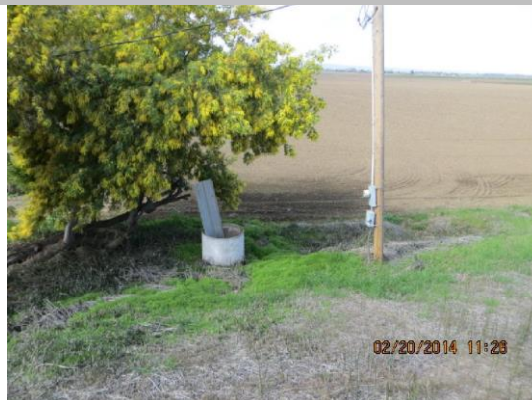
Photo 2 of 3 : UCIP\_FA\_2018\_30577\_56344.jpg

Concrete standpipe, powerpole, and meter visible on LS toe.

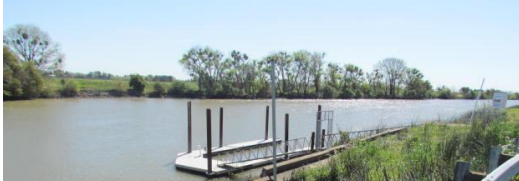
Photo 1 of 1 : FA\_2018\_RD0003\_25\_59\_20180925\_00044.jpg

Looking southeast at concrete structure on waterward slope.

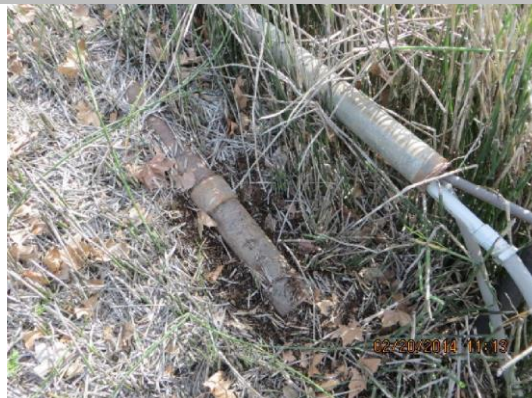
Photo 1 of 1 : UCIP\_FA\_2018\_30568\_56321.jpg

LM Start	8.46	Rating **	M	Issue No.	974
LM End	8.46	Issue Type +	En	Location *	
Category	Supplemental			GPS Latitude/Longitude	
				Start	End
Item	DWR UCIP Field Study			38.229127 °	38.229127 °
				-121.557189 °	-121.557189 °
DWR ID	22259				
Comment Code					
Inspector Comment					
FS_ID:30568 DS_ID:22259 EP_NO: N/A Repair Type: Non-Urgent Crossing Status: Found UCIP Comments: Pipe abandoned and should be done so properly. Rusted through and open on LS slope. Possibly just a section of discarded pipe. FIELD_STRUCT_DESC: *ABANDONED* 5-inch steel pipe of an unknown purpose through the levee, 5 feet below the crown. Open on the landside (LS) end. [Additional Reference(s): DWR Levee Log, 1993]. FS Date: 2/20/2014

Steel pipe visible on LS Slope.

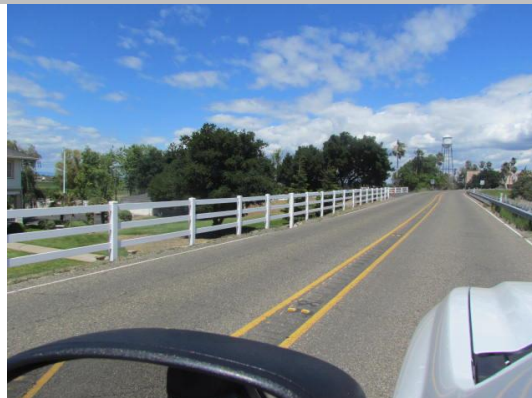
Photo 1 of 1 : FA\_2018\_RD0003\_25\_78\_20180925\_00061.jpg

LM Start	8.85	Rating **	M	Issue No.	78
LM End	8.93	Issue Type +	En	Location *	LS
Category	Earthen Levee			GPS Latitude/Longitude	
				Start	End
Item	Encroachments			38.234516 °	38.235630 °
				-121.559502 °	-121.559640 °
DWR ID	DWR_RD0003_02_s_2013_78				
Comment Code					
FE : Fence					
Inspector Comment					
Unauthorized fence.

Looking northwest at unauthorized fence on landward shoulder.

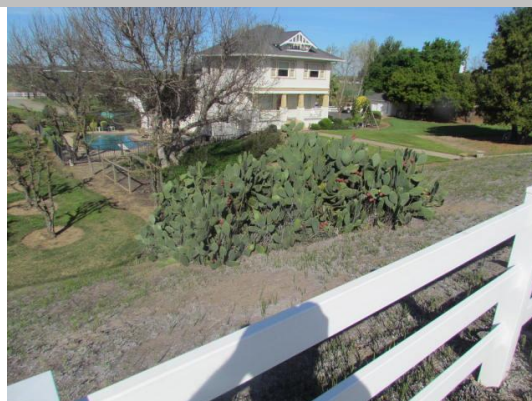
Photo 1 of 1 : FA\_2018\_RD0003\_25\_158\_20180925\_00134.jpg

LM Start	8.87	Rating **	U	Issue No.	158
LM End	8.87	Issue Type +	En	Location *	LS
Category	Earthen Levee			GPS Latitude/Longitude	
				Start	End
Item	Vegetation			38.234759 °	38.234759 °
				-121.559534 °	-121.559534 °
DWR ID	DWR_RD0003_02_s_2015_158				
Comment Code					
V6 : Landscaping					
Inspector Comment					
Large cluster of cactus on landside slope.

Looking west at cactus on landward slope and toe.

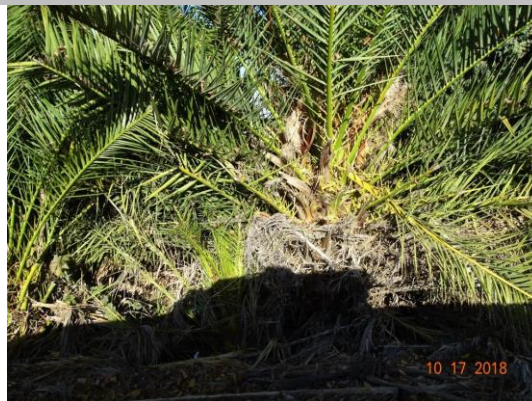
Photo 1 of 1 : FA\_2018\_RD0003\_25\_182\_20181018\_00296.jpg

LM Start	<b>9.16</b>	Rating **	U	Issue No.	<b>182</b>
LM End	<b>9.16</b>	Issue Type +	En	Location *	LS
Category	Earthen Levee		GPS Latitude/Longitude		
			Start	End	
Item	Vegetation		38.238812 °	38.238812 °	
			-121.558187 °	-121.558187 °	
DWR ID	DWR_RD0003_02_f_2018_182				
Comment Code					
V6 : Landscaping					
Inspector Comment					
Palm trees blocking view of levee.

View of palm trees at the top of the land side slope (October 2018).

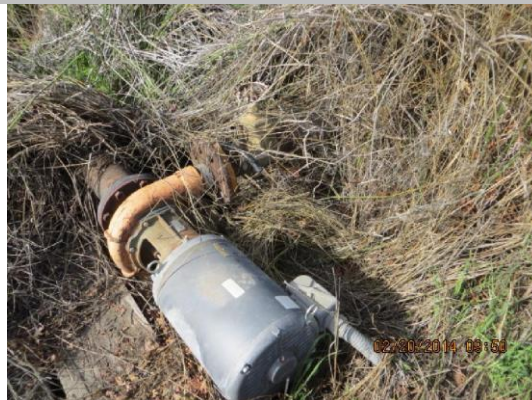
Photo 2 of 3 : UCIP\_FA\_2018\_30507\_56119.jpg

Comment Code						
Inspector Comment						
FS_ID:30507 DS_ID:22271 EP_NO: 3295 Repair Type: Non-Urgent Crossing Status: Found UCIP Comments: Possibly Abandoned and if so should be done properly. Pipe shows sigs of decay on LS toe and there is pipe debris on the WS slope. Good candidate for video inspection. FIELD_STRUCT_DESC: 10-inch steel irrigation discharge pipe through the levee, 6.5 feet below the crown. Pump on the waterside (WS) slope with a gate valve. Gate valve, power pole, and meter visible on the landside (LS) toe. 1.5-inch steel electrical conduit through the levee at the same location. (Plans for installation of a pump and motor on the WS slope of the levee and installation of an 8-inch pipe through an existing 12-inch pipe through the levee authorized under Permit No. 3295, 1960 - Robert and Craig James). [Additional Reference(s): DWR Levee Log, 1993]. FS Date: 2/20/2014

Pump and gate valve on WS slope.

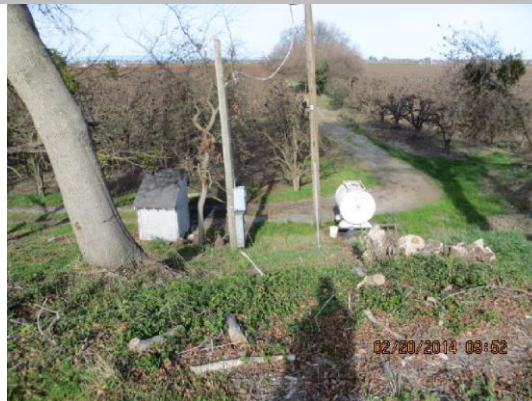
Photo 3 of 3 : UCIP\_FA\_2018\_30507\_56118.jpg

Pipe to left of power pole and meter at LS toe.

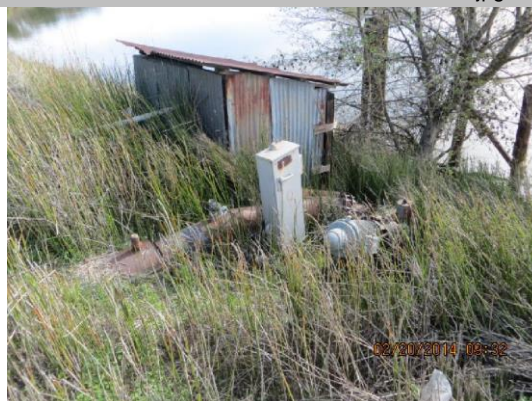
Photo 1 of 3 : UCIP\_FA\_2018\_53270\_57439.jpg

Comment Code						
Inspector Comment						
FS_ID:53270 DS_ID:22272 EP_NO: 1136 Repair Type: Urgent Crossing Status: Found UCIP Comments: 07/20/2018 Everything appears to be the same as last time. No changes have been made. This crossing remains "Urgent": need to determine the condition of the pipe through the levee. (A. McDonald - DWR UCIP)07/06/2016 Highway has been since paved so pot hole not visible. No evidence of repair. (DWR UCIP - kfazel)02/20/2014 Dip in pavement over pipe on North bound lane may indicate internal leak in pipe. Good candidate for video inspection. (DWR UCIP - pamatya) FIELD_STRUCT_DESC: 16-inch steel irrigation discharge pipe through the levee, invert elevation 6.2 feet below the crown. 12-inch steel pipe sleeved through the existing 16-inch pipe with the annular space grouted. Slant pump on the waterside (WS) slope next to the pump house. Butterfly valve and siphon breaker/vent at the pump on the WS slope. Siphon breaker/vent on the landside (LS) shoulder. Filter, pump, vent, and butterfly valve at the LS toe. The current 16-inch pipe replaced the abandoned 10-inch pipe under DSID 22273. (Plans for plugging up an existing 10-inch steel discharge pipe and installing a new 16-inch steel discharge pipe through the levee authorized under Permit No. 1136, 1946 - Dennis W. Leary. Plans to install a 12-inch irrigation intake pipe inside an existing 16-inch pipe in the levee authorized under Permit No. 14811, 1988 - Leary Ranch, Inc). [Additional Reference(s): DWR Levee Log, 1993. USACE Sacramento O&M Manual 104, February 1960, (RM 24.32), 14-inch pipe referenced]. FS Date: 7/20/2018

Pump, pipe, butterfly valve, and shed visible on WS slope.

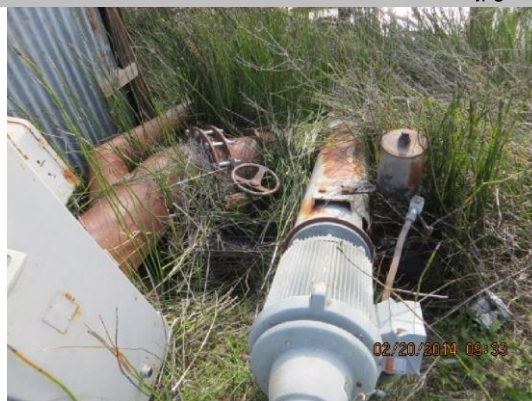
Photo 2 of 3 : UCIP\_FA\_2018\_53270\_57438.jpg

UCIP Comments: 07/20/2018 Everything appears to be the same as last time. No changes have been made. This crossing remains "Urgent": need to determine the condition of the pipe through the levee. (A. McDonald - DWR UCIP)07/06/2016 Highway has been since paved so pot hole not visible. No evidence of repair. (DWR UCIP - kfazel)02/20/2014 Dip in pavement over pipe on North bound lane may indicate internal leak in pipe. Good candidate for video inspection. (DWR UCIP - pamatya)

Pump, pipe, butterfly valve, and shed visible on WS slope.

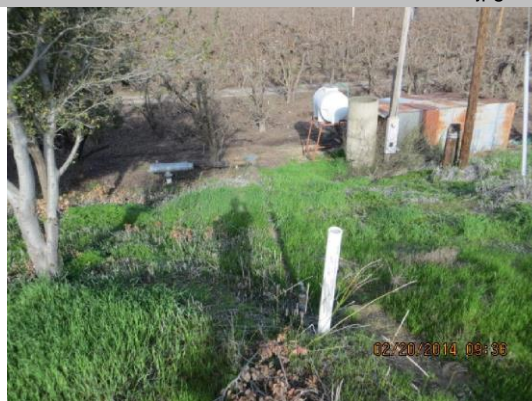
Photo 3 of 3 : UCIP\_FA\_2018\_53270\_57437.jpg

FS_ID:53270 DS_ID:22272 EP_NO: 1136 Repair Type: Urgent Crossing Status: Found UCIP Comments: 07/20/2018 Everything appears to be the same as last time. No changes have been made. This crossing remains "Urgent": need to determine the condition of the pipe through the levee. (A. McDonald - DWR UCIP)07/06/2016 Highway has been since paved so pot hole not visible. No evidence of repair. (DWR UCIP - kfazel)02/20/2014 Dip in pavement over pipe on North bound lane may indicate internal leak in pipe. Good candidate for video inspection. (DWR UCIP - pamatya) FIELD_STRUCT_DESC: 16-inch steel irrigation discharge pipe through the levee, invert elevation 6.2 feet below the crown. 12-inch steel pipe sleeved through the existing 16-inch pipe with the annular space grouted. Slant pump on the waterside (WS) slope next to the pump house. Butterfly valve and siphon breaker/vent at the pump on the WS slope. Siphon breaker/vent on the landside (LS) shoulder. Filter, pump, vent, and butterfly valve at the LS toe. The current 16-inch pipe replaced the abandoned 10-inch pipe under DSID 22273. (Plans for plugging up an existing 10-inch steel discharge pipe and installing a new 16-inch steel discharge pipe through the levee authorized under Permit No. 1136, 1946 - Dennis W. Leary. Plans to install a 12-inch irrigation intake pipe inside an existing 16-inch pipe in the levee authorized under Permit No. 14811, 1988 - Leary Ranch, Inc). [Additional Reference(s): DWR Levee Log, 1993. USACE Sacramento O&M Manual 104, February 1960, (RM 24.32), 14-inch pipe referenced]. FS Date: 7/20/2018

Vent/siphon breaker on LS shoulder.

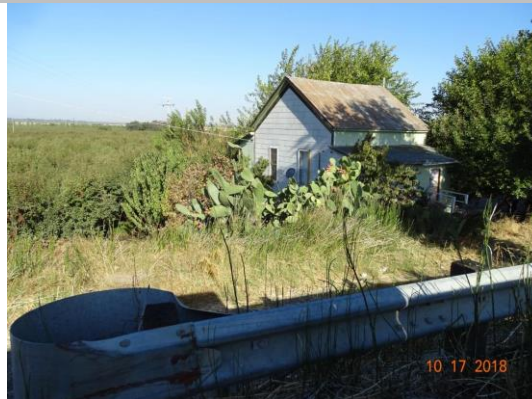
Photo 1 of 1 : FA\_2018\_RD0003\_25\_100\_20181018\_00295.jpg

LM Start	9.37	Rating **	M	Issue No.	100
LM End	9.37	Issue Type +	En	Location *	LS
Category	Earthen Levee			GPS Latitude/Longitude	
				Start	End
Item	Vegetation			38.241199 °	38.241199 °
				-121.555867 °	-121.555867 °
DWR ID	DWR_RD0003_02_f _ 2013_100				
Comment Code					
V6 : Landscaping					
Inspector Comment					
Cactus on landside slope. Palm trees have been removed.

View of cactus on the land side slope (October 2018).

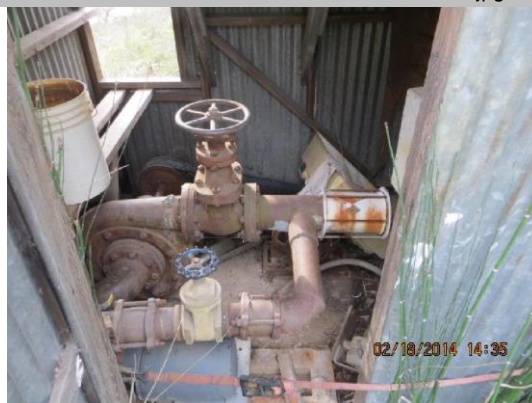
Photo 1 of 3 : UCIP\_FA\_2018\_31349\_57435.jpg

Comment Code						
Inspector Comment						
FS_ID:31349						
DS_ID:22275						
EP_NO: 3738						
Repair Type: Non-Urgent						
Crossing Status: Found						
UCIP Comments: Heavy foliage over pipe and appurtances on LS slope.						
FIELD_STRUCT_DESC: 6-inch steel irrigation discharge pipe through the levee, invert elevation 5.5 feet below the crown. Pump and gate valve in a pump house on the waterside (WS) slope. 1.5-inch steel electrical conduit through the levee at the same location. (Plans to insert a new 4-inch pipe through an existing 6-inch irrigation pipe through the levee authorized under Permit No. 3738, 1961 - Emmett James). [Additional Reference(s): DWR Levee Log, 1993. USACE Sacramento O&M Manual 104, February 1960, (RM 24.48)].						
FS Date: 2/18/2014

Pump, pipe, and gate valves in pumphouse on WS slope.

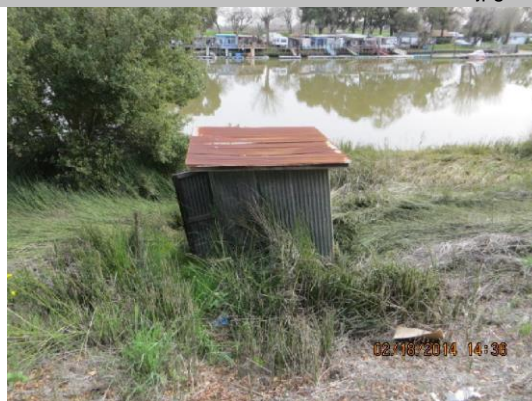
Photo 2 of 3 : UCIP\_FA\_2018\_31349\_57434.jpg

Comment Code						
Inspector Comment						
FS_ID:31349 DS_ID:22275 EP_NO: 3738 Repair Type: Non-Urgent Crossing Status: Found UCIP Comments: Heavy foliage over pipe and appurtances on LS slope. FIELD_STRUCT_DESC: 6-inch steel irrigation discharge pipe through the levee, invert elevation 5.5 feet below the crown. Pump and gate valve in a pump house on the waterside (WS) slope. 1.5-inch steel electrical conduit through the levee at the same location. (Plans to insert a new 4-inch pipe through an existing 6-inch irrigation pipe through the levee authorized under Permit No. 3738, 1961 - Emmett James). [Additional Reference(s): DWR Levee Log, 1993. USACE Sacramento O&M Manual 104, February 1960, (RM 24.48)]. FS Date: 2/18/2014

Pumphouse on WS slope.

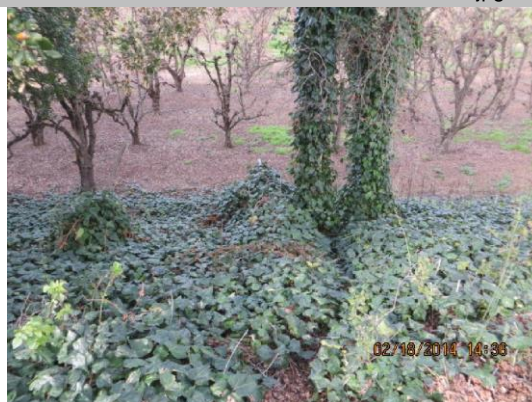
Photo 3 of 3 : UCIP\_FA\_2018\_31349\_57433.jpg

Pipe visible at LS toe.

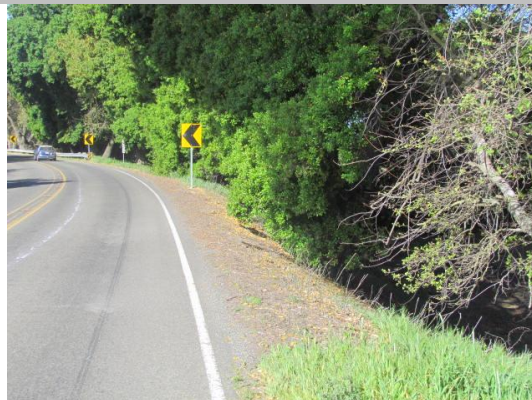
Photo 1 of 1 : FA\_2018\_RD0003\_25\_64\_20180925\_00046.jpg

LM Start	9.56	Rating **	M	Issue No.	64
LM End	9.62	Issue Type +	Ma	Location *	LS
Category	Earthen Levee			GPS Latitude/Longitude	
				Start	End
Item	Trim / Thin Trees			38.242392 °	38.242501 °
				-121.552862 °	-121.551632 °
DWR ID	DWR_RD0003_02_s_2012_64				
Comment Code					
T1 : Trim trees to at least five feet above ground level.					
Inspector Comment

Looking southwest at dense trees on landward shoulder and slope.

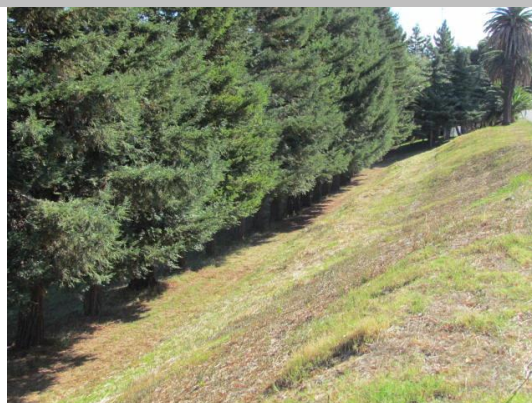
Photo 1 of 2 : FA\_2018\_RD0003\_25\_101\_20180925\_00083.jpg

LM Start	9.63	Rating **	M	Issue No.	101
LM End	9.77	Issue Type +	En	Location *	LS
Category	Earthen Levee			GPS Latitude/Longitude	
				Start	End
Item	Vegetation			38.242471 °	38.242251 °
				-121.551426 °	-121.548970 °
DWR ID	DWR_RD0003_02_f_2013_101				
Comment Code					
V6 : Landscaping					
Inspector Comment					
Large redwood trees at the landside toe and berm.

Looking northeast at dense redwood trees on landward toe and berm.

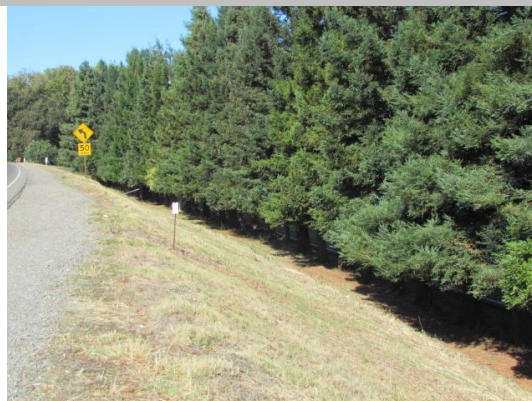
Photo 2 of 2 : FA\_2018\_RD0003\_25\_101\_20180925\_00084.jpg

Looking southwest at dense redwood trees on landward toe and berm.

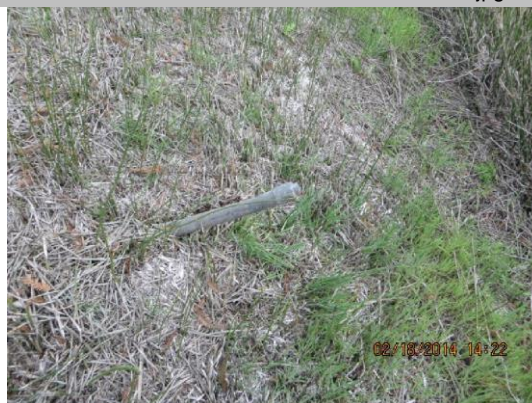
Photo 1 of 1 : UCIP\_FA\_2018\_30424\_55960.jpg

LM Start	9.69	Rating **	M	Issue No.	978
LM End	9.69	Issue Type +	En	Location *	
Category	Supplemental			GPS Latitude/Longitude	
				Start	End
Item	DWR UCIP Field Study			38.242415 °	38.242415 °
				-121.550452 °	-121.550452 °
DWR ID	22277				
Comment Code					
Inspector Comment					
FS_ID:30424					
DS_ID:22277					
EP_NO: N/A					
Repair Type: Non-Urgent					
Crossing Status: Found					
UCIP Comments: Pipe is not grouted properly.					
FIELD_STRUCT_DESC: *ABANDONED* 14-inch steel irrigation discharge pipe through the levee, 5.7 feet below the crown. (Pipe capped on both ends by USACE in 1964). 1.5-inch steel electrical conduit through the levee at the same location, visible on both sides of the levee and capped. [Additional Reference(s): DWR Levee Log, 1993].					
FS Date: 2/18/2014

Electrical conduit visible on WS slope.

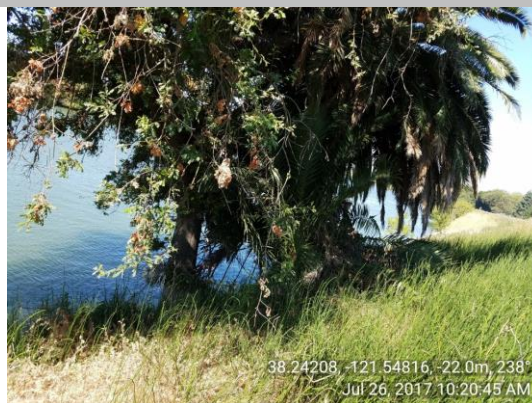
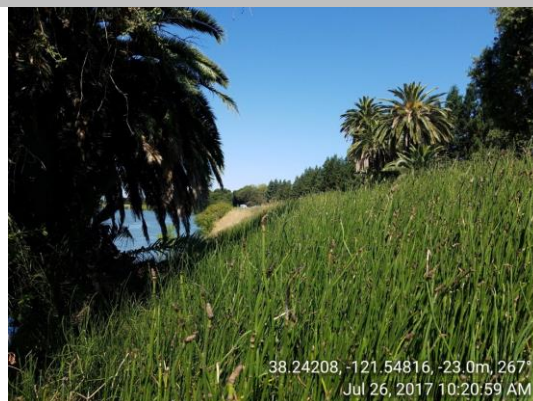
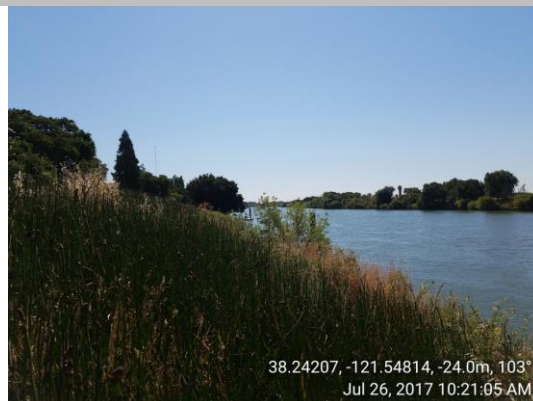
LM Start	9.82	Rating **	A/W	Issue No.	137
LM End	9.84	Issue Type +	Ma	Location *	
Category	Supplemental			GPS Latitude/Longitude	
				Start	End
Item	2017 Storm Damage			38.242006 °	38.241950 °
				-121.548117 °	-121.547681 °
DWR ID	DWR_RD0003_02_f_2017_137				
Comment Code					
Inspector Comment					
Levee Evaluation Comments					
Description: District station 518+55 to 519+81 , Sec. 33, T. 5 N. R. 4 E., M.D.M. Approximately 126 linear feet of erosion and sloughing exists along the water side slope of the Sacramento River (Unit 2). The erosion commences approximately 1/4 of the way down the slope from the crown and extends into the rip rap.					
Site ID No: 279					
Site Designation: LMA-105					
Repair Type: Erosion					
Rating: Area of Concern					
Field Date: 7/26/2017					
Notes:

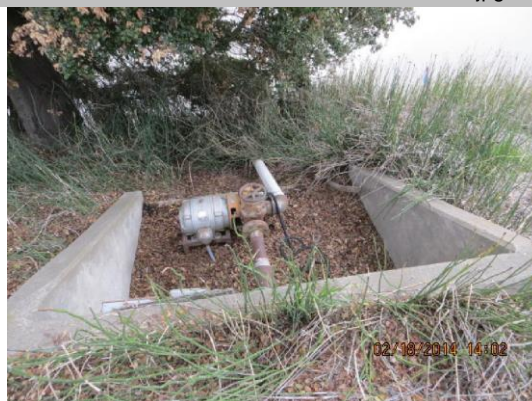
Photo 1 of 3 : UCIP\_FA\_2018\_30408\_55931.jpg

Comment Code						
Inspector Comment						
FS_ID:30408 DS_ID:22280 EP_NO: N/A Repair Type: Non-Urgent Crossing Status: Found UCIP Comments: Annular space not grouted. FIELD_STRUCT_DESC: 6-inch steel irrigation discharge pipe through the levee, invert elevation 5.5 feet below the crown. A 3.5-inch steel pipe is sleeved through a 5-inch pipe which is sleeved through the 6-inch pipe. The annular space is not grouted. Pump and gate valve on the waterside (WS) slope. Concrete distribution box at the landside (LS) toe. 1.5-inch electrical conduit through the levee at the same location. Service pole at the LS toe. (Joe Dianda). [Additional Reference(s): DWR Levee Log, 1993. USACE Sacramento O&M Manual 104, February 1960, (RM 24.88)]. FS Date: 2/18/2014

Pump and shutoff valve on concrete pad on WS slope.

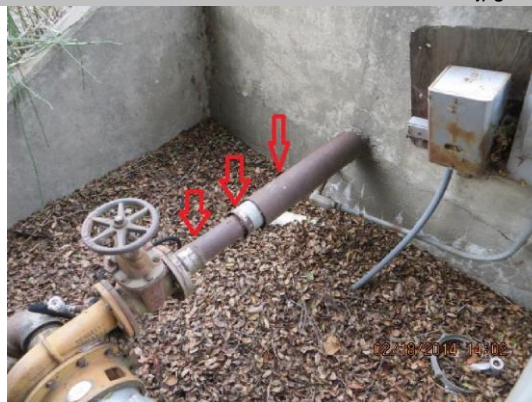
Photo 2 of 3 : UCIP\_FA\_2018\_30408\_55930.jpg

2 pipes sleeved through 6-inch pipe.

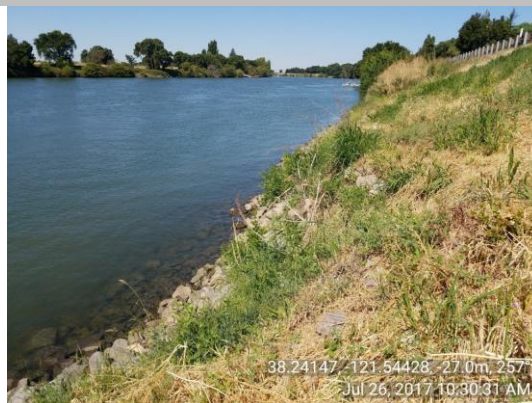
LM Start	10.01	Rating **	A/W	Issue No.	138 (cont)	
LM End	10.03	Issue Type +	Ma	Location *		
Category	Supplemental			GPS Latitude/Longitude		
				Start	End	
Item	2017 Storm Damage			38.241481 °	38.241439 °	
				-121.544569 °	-121.544353 °	
DWR ID	DWR_RD0003_02_f_2017_138					
Comment Code						
Inspector Comment						
Levee Evaluation Comments						
Description: District station 528+97 to 529+58, Sec. 33, T. 5 N. R. 4 E., M.D.M. Approximately 61 linear feet of erosion and sloughing exists along the water side slope of the Sacramento River (Unit 2). The erosion commences approximately 1/2 of the way down the slope from the crown and extends into the rip rap.						
Site ID No: 280						
Site Designation: LMA-106						
Repair Type: Erosion						
Rating: Area of Concern						
Field Date: 7/26/2017						
Notes:

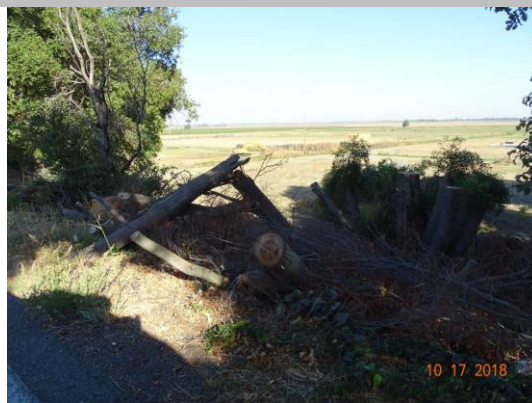
Photo 1 of 1 : FA\_2018\_RD0003\_25\_167\_20181018\_00294.jpg

LM Start	10.05	Rating **	U	Issue No.	167
LM End	10.05	Issue Type +	En	Location *	LS
Category	Earthen Levee			GPS Latitude/Longitude	
				Start	End
Item	Encroachments			38.241522 °	38.241522 °
				-121.543883 °	-121.543883 °
DWR ID	DWR_RD0003_02_f_2018_167				
Comment Code					
TR : Tree or limb					
Inspector Comment					
Remove tree debris from landside slope.

View of partially removed tree on land side slope (October 2018).

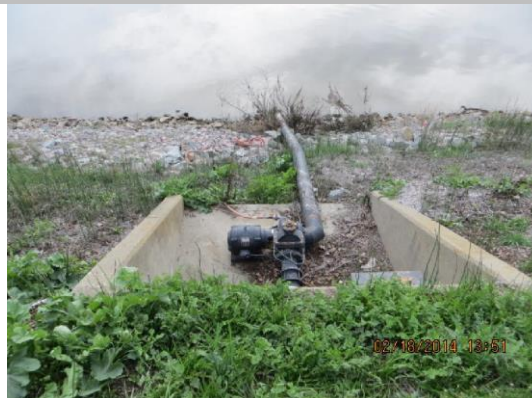
Photo 1 of 3 : UCIP\_FA\_2018\_30406\_55927.jpg

Comment Code						
Inspector Comment						
FS_ID:30406 DS_ID:22281 EP_NO: N/A Repair Type: Non-Urgent Crossing Status: Found UCIP Comments: Actuator for Gate valve is broken off. FIELD_STRUCT_DESC: 8-inch steel irrigation discharge pipe through the levee, invert elevation 6.5 feet below the crown. Pipe reduced to 6 inches on the slopes. Pump and gate valve on a concrete pad on the waterside (WS) slope. Siphon breaker on the landside (LS) slope. (DWR Bank Protection Project, Drawing No. 50-4-3741, Sheet 21 - Castanho). [Additional Reference(s): DWR Levee Log, 1993. USACE Sacramento O&M Manual 104, February 1960, (RM 25.09), 6-inch pipe referenced]. FS Date: 2/18/2014

Pump, gate valve, and concrete pad on WS slope.

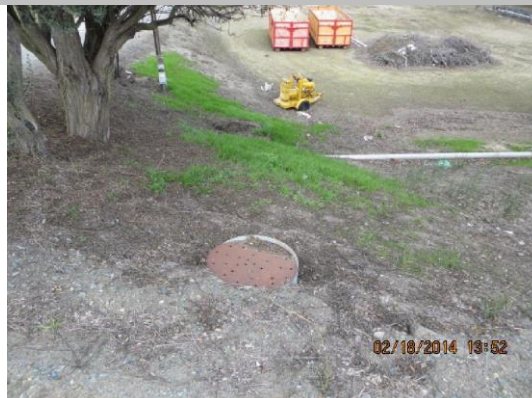
Photo 2 of 3 : UCIP\_FA\_2018\_30406\_55926.jpg

Siphon Breaker in CMP riser on LS shoulder.

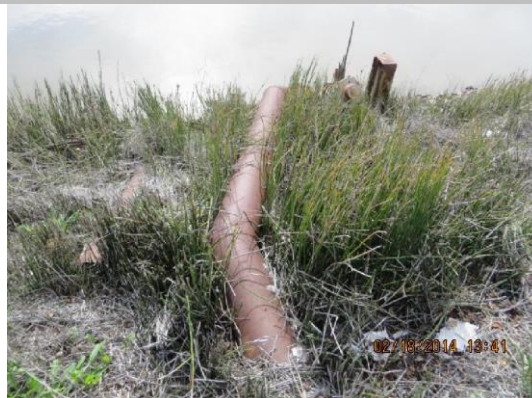
Photo 1 of 2 : UCIP\_FA\_2018\_30404\_55924.jpg

Comment Code						
Inspector Comment						
FS_ID:30404 DS_ID:22282 EP_NO: 3670 Repair Type: Non-Urgent Crossing Status: Found UCIP Comments: Appears abandoned as no pipe, siphon breaker, or standpipe visible on LS toe. If so, it should be abandoned properly. FIELD_STRUCT_DESC: 12-inch steel irrigation discharge pipe through the levee, 3.8 feet below the crown. Slant pump on the waterside (WS) slope. Siphon breaker on the landside (LS) shoulder. (Plans to remove an old centrifugal pump and suction pipe, to install a new propeller pump 40 feet in length along the slope of the levee, to install necessary foundation piling to support the pump, and to connect to present pipe through the levee authorized under Permit No. 3670, 1961 - Russell G. Graham. Plans to replace a section of an existing irrigation pipe with a 12-inch steel pipe through the crown of the levee authorized under Permit No. 17837, 2004 - Ron Galindo). [Additional Reference(s): DWR Levee Log, 1993]. FS Date: 2/18/2014

Pipe and slant pump visible on WS slope.

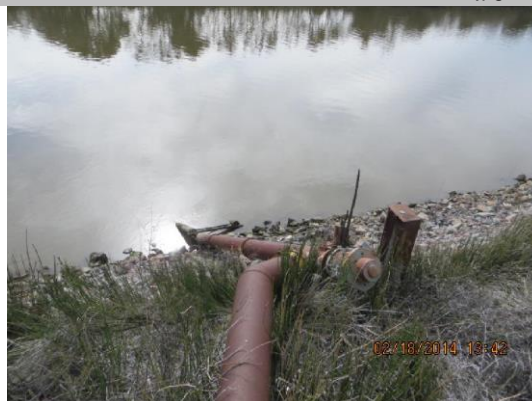
Photo 2 of 2 : UCIP\_FA\_2018\_30404\_55923.jpg

Pipe and slant pump visible on WS slope.

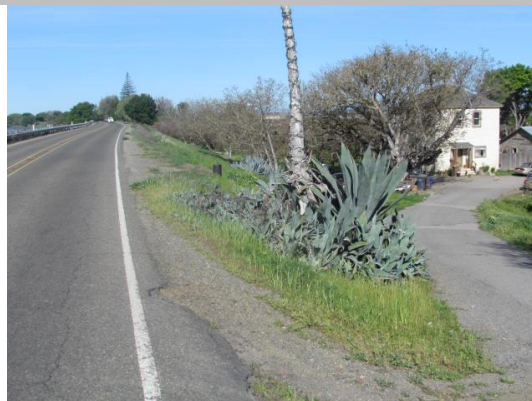
Photo 1 of 2 : FA\_2018\_RD0003\_25\_81\_20180925\_00064.jpg

LM Start	10.43	Rating **	M	Issue No.	81
LM End	10.43	Issue Type +	En	Location *	LS
Category	Earthen Levee			GPS Latitude/Longitude	
				Start	End
Item	Vegetation			38.239850 °	38.239850 °
				-121.537237 °	-121.537237 °
DWR ID	DWR_RD0003_02_s_2013_81				
Comment Code					
V6 : Landscaping					
Inspector Comment					
Century plant on landside shoulder.

Looking west at century plant on landward slope. (Spring 2015)

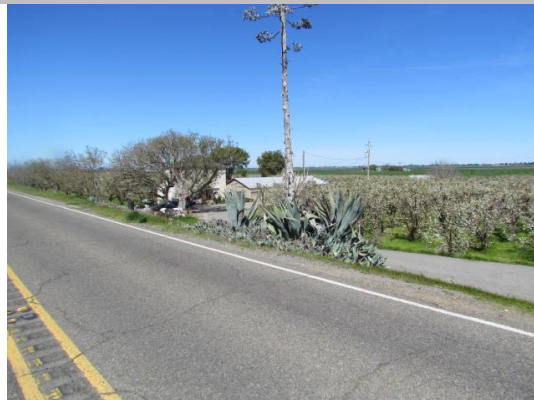
Photo 2 of 2 : FA\_2018\_RD0003\_25\_81\_20180925\_00065.jpg

Looking northwest at century plant on landward shoulder and slope.

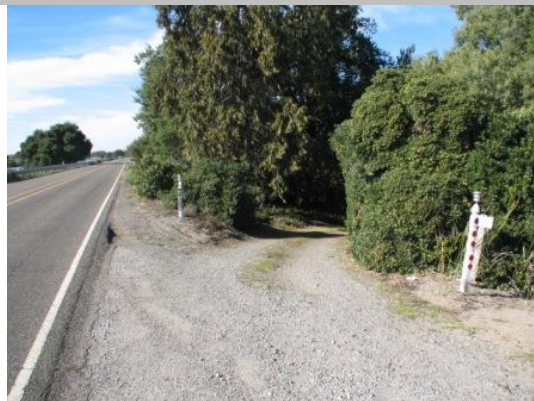
Photo 1 of 1 : FA\_2018\_RD0003\_25\_66\_20180925\_00047.jpg

LM Start	10.53	Rating **	U	Issue No.	66
LM End	10.53	Issue Type +	En	Location *	LS
Category	Earthen Levee			GPS Latitude/Longitude	
				Start	End
Item	Vegetation			38.239462 °	38.239462 °
				-121.535462 °	-121.535462 °
DWR ID	DWR_RD0003_02_s_2012_66				
Comment Code					
V6 : Landscaping					
Inspector Comment

Landscaping on levee slope and toe obstructs access and visibility.

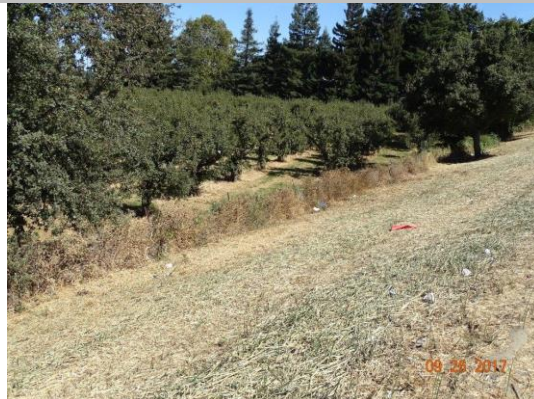
Photo 1 of 1 : FA\_2018\_RD0003\_25\_174\_20180925\_00144.jpg

LM Start	10.69	Rating **	M	Issue No.	174
LM End	10.69	Issue Type +	En	Location *	LS
Category	Earthen Levee			GPS Latitude/Longitude	
				Start	End
Item	Encroachments			38.238921 °	38.238921 °
				-121.532573 °	-121.532573 °
DWR ID	DWR_RD0003_02_f_2017_174				
Comment Code					
FE : Fence					
Inspector Comment					
Barbed wire fence at landside toe blocking access.

Looking northeast at the landside slope.

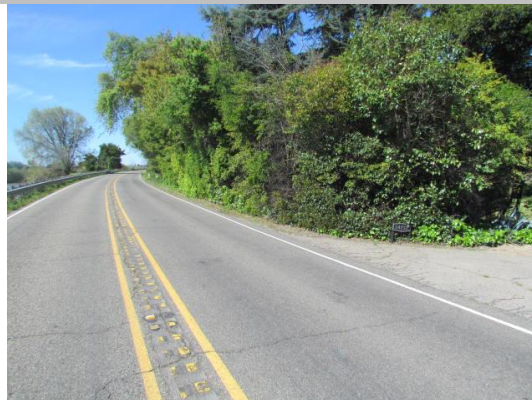
Photo 1 of 1 : FA\_2018\_RD0003\_25\_68\_20180925\_00049.jpg

LM Start	10.74	Rating **	U	Issue No.	68	
LM End	10.90	Issue Type +	En	Location *	LS	
Category	Earthen Levee			GPS Latitude/Longitude		
				Start		End
Item	Vegetation			38.238788 °		38.238959 °
				-121.531698 °		-121.528758 °
DWR ID	DWR_RD0003_02_s_2012_68					
Comment Code						
V6 : Landscaping						
Inspector Comment

Looking west at dense landscaping on landward shoulder and slope.

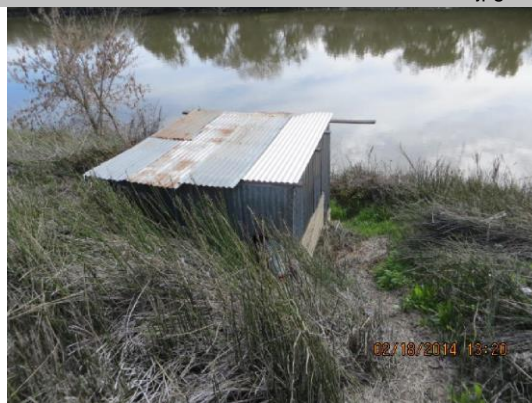
Photo 1 of 3 : UCIP\_FA\_2018\_30391\_55899.jpg

Comment Code						
Inspector Comment						
FS_ID:30391 DS_ID:22284 EP_NO: 9442 Repair Type: Non-Urgent Crossing Status: Found UCIP Comments: Good candidate for video inspection. FIELD_STRUCT_DESC: 8-inch steel irrigation discharge pipe through the levee, invert elevation 7.5 feet below the crown. Pump and gate valve on the waterside (WS) slope. 4-foot by 4-foot concrete distribution box at the landside (LS) toe, next to a power pole and meter. 1.5-inch electrical conduit through the levee at the same location. (Retention of an irrigation pumping plant, centrifugal pump, and accessories in a corrugated metal shed on the WS levee slope and an 8-inch pipe through the levee above the floodplain authorized under Automatic Board Order (ABO) issued as Permit No. 9442, 1974 - Frank Gwerder). [Additional Reference(s): DWR Levee Log, 1993. USACE Sacramento O&M Manual 104, February 1960, (RM 25.74), 6-inch pipe referenced]. FS Date: 2/18/2014

Pump and gate valve in pumphouse on WS slope.

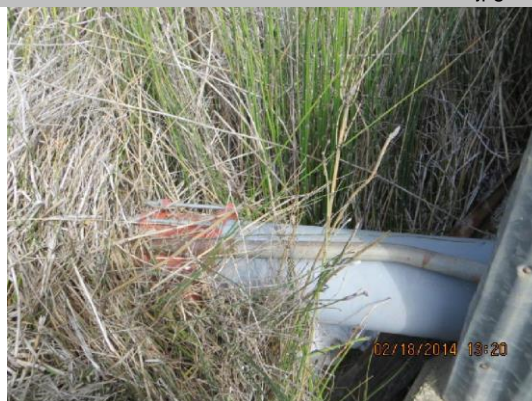
Photo 2 of 3 : UCIP\_FA\_2018\_30391\_55898.jpg

Pipe and conduit visible on WS slope.

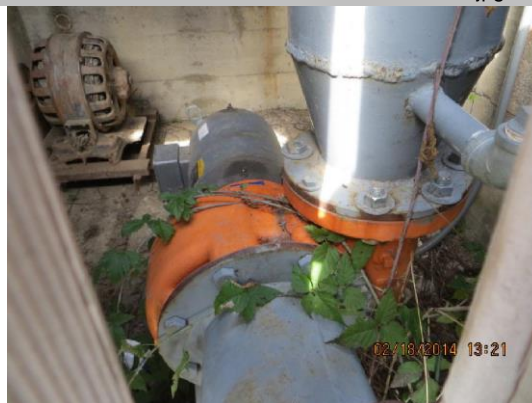
Photo 3 of 3 : UCIP\_FA\_2018\_30391\_55897.jpg

Pump in pumphouse on WS slope.

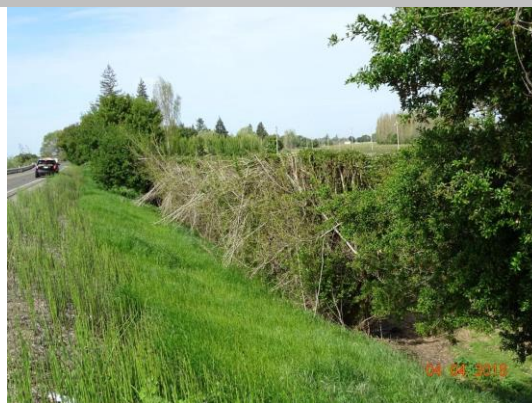
Photo 1 of 1 : FA\_2018\_RD0003\_25\_160\_20180925\_00136.jpg

LM Start	10.90	Rating **	U	Issue No.	160
LM End	11.08	Issue Type +	En	Location *	LS
Category	Earthen Levee			GPS Latitude/Longitude	
				Start	End
Item	Vegetation			38.238962 °	38.239706 °
				-121.528842 °	-121.525707 °
DWR ID	DWR_RD0003_02_s_2018_160				
Comment Code					
V6 : Landscaping					
Inspector Comment					
Row of closely-spaced trees at landside toe inhibits inspection and prevents access.

Trees at landside toe.

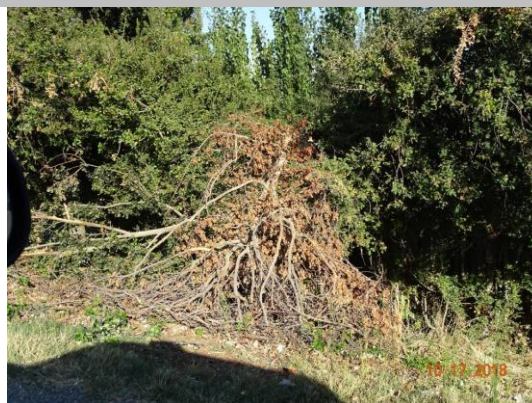
Photo 1 of 1 : FA\_2018\_RD0003\_25\_163\_20181018\_00293.jpg

LM Start	10.99	Rating **	M	Issue No.	163
LM End	10.99	Issue Type +	Ma	Location *	LS
Category	Earthen Levee			GPS Latitude/Longitude	
				Start	End
Item	Encroachments			38.239377 °	38.239377 °
				-121.527177 °	-121.527177 °
DWR ID	DWR_RD0003_02_f_2018_163				
Comment Code					
TR : Tree or limb					
Inspector Comment					
Remove dead branch.

View of dead branch on land side slope (October 2018).

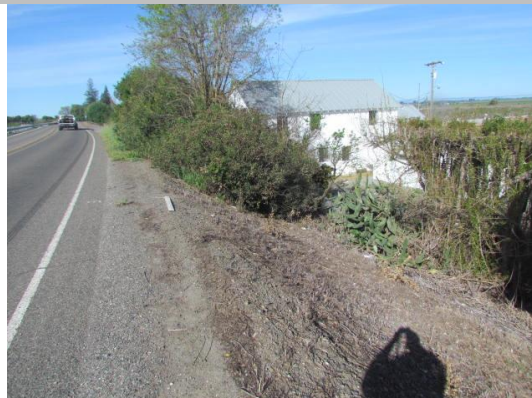
Photo 1 of 2 : FA\_2018\_RD0003\_25\_84\_20180925\_00069.jpg

LM Start	11.10	Rating **	U	Issue No.	84
LM End	11.10	Issue Type +	En	Location *	LS
Category	Earthen Levee			GPS Latitude/Longitude	
				Start	End
Item	Vegetation			38.239730°	38.239730°
				-121.525190°	-121.525190°
DWR ID	DWR_RD0003_02_s_2013_84				
Comment Code					
V6 : Landscaping					
Inspector Comment					
Oleander and cactus on landside shoulder.

Looking west at dense landscaping on landward slope and toe. (Spring 2015)

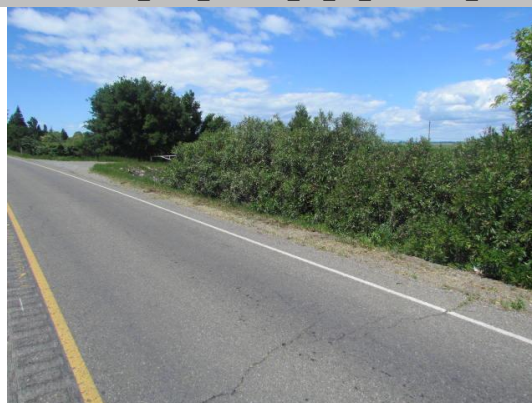
Photo 2 of 2 : FA\_2018\_RD0003\_25\_84\_20180925\_00070.jpg

Looking northwest at dense landscaping on landward shoulder and slope.

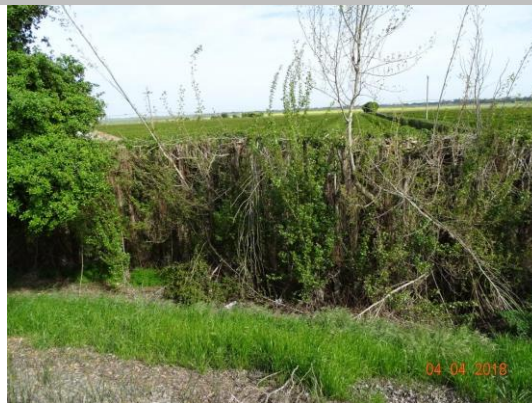
Photo 1 of 1 : FA\_2018\_RD0003\_25\_153\_20180925\_00130.jpg

LM Start	11.13	Rating **	U	Issue No.	153
LM End	11.13	Issue Type +	En	Location *	LS
Category	Earthen Levee			GPS Latitude/Longitude	
				Start	End
Item	Vegetation			38.239858 °	38.239858 °
				-121.524747 °	-121.524747 °
DWR ID	DWR_RD0003_02_s_2018_153				
Comment Code					
V6 : Landscaping					
Inspector Comment					
Row of closely-spaced trees at landside toe inhibits inspection and prevents access.

Row of trees at landside toe.

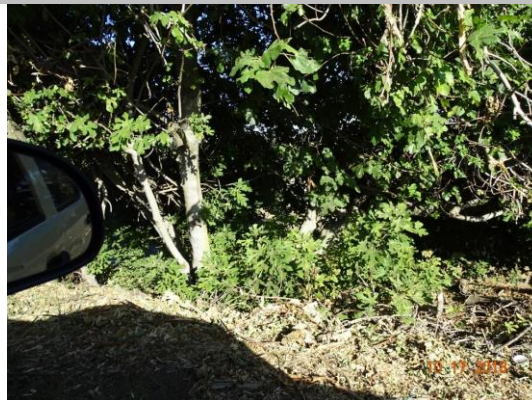
Photo 1 of 1 : FA\_2018\_RD0003\_25\_148\_20181018\_00292.jpg

LM Start	11.21	Rating **	U	Issue No.	148
LM End	11.21	Issue Type +	Ma	Location *	LS
Category	Earthen Levee			GPS Latitude/Longitude	
				Start	End
Item	Trim / Thin Trees			38.239968 °	38.239968 °
				-121.523293 °	-121.523293 °
DWR ID	DWR_RD0003_02_f_2018_148				
Comment Code					
T1 : Trim trees to at least five feet above ground level.					
Inspector Comment					
Trim fig trees that are sprouting

View of newly sprouting fig trees on the land side slope (October 2018).

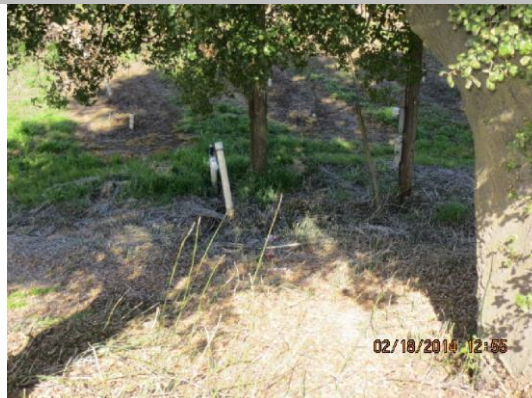
Photo 1 of 3 : UCIP\_FA\_2018\_30364\_55846.jpg

LM Start	11.25	Rating **	M	Issue No.	983
LM End	11.25	Issue Type +	En	Location *	
Category	Supplemental			GPS Latitude/Longitude	
				Start	End
Item	DWR UCIP Field Study			38.239992 °	38.239992 °
				-121.522463 °	-121.522463 °
DWR ID	22288				
Comment Code					
Inspector Comment					
FS_ID:30364 DS_ID:22288 EP_NO: N/A Repair Type: Non-Urgent Crossing Status: Found UCIP Comments: Annular space not grouted. FIELD_STRUCT_DESC: 8-inch steel irrigation discharge pipe through the levee, invert elevation 6.7 feet below the crown. A 4-inch polyvinyl chloride (PVC) pipe is sleeved through the 8-inch pipe. Pump and gate valve in a pump house on the waterside (WS) slope. (Johnson). [Additional Reference(s): DWR Levee Log, 1993. USACE Sacramento O&M Manual 104, February 1960, (RM 26.25)]. FS Date: 2/18/2014

PVC pipe, pole, and meter visible on LS toe.

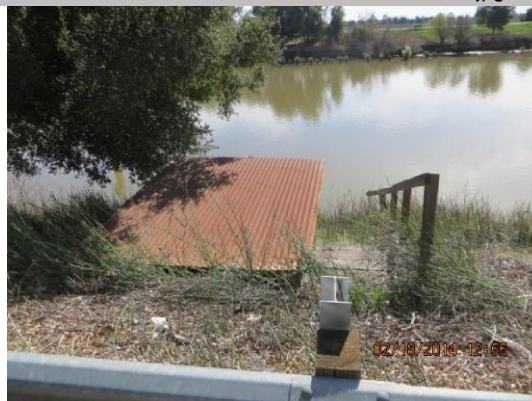
Photo 2 of 3 : UCIP\_FA\_2018\_30364\_55845.jpg

Pipe visible in abandoned pumphouse on WS slope.

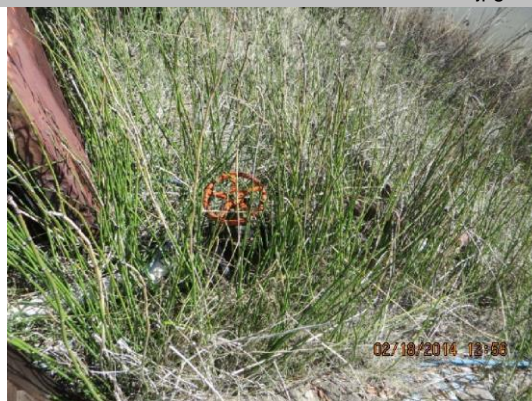
Photo 3 of 3 : UCIP\_FA\_2018\_30364\_55844.jpg

Shutoff valve at pump on WS slope.

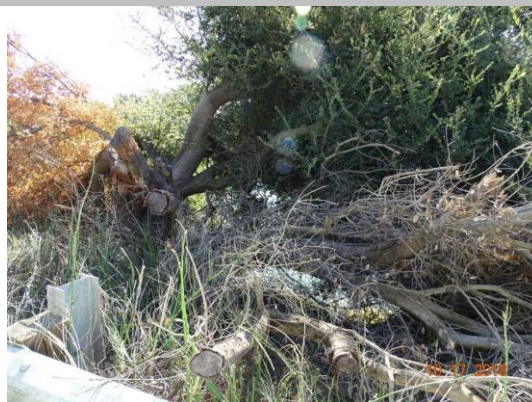
Photo 1 of 1 : FA\_2018\_RD0003\_25\_201\_20181018\_00307.jpg

LM Start	11.26	Rating **	U	Issue No.	201
LM End	11.26	Issue Type +	Ma	Location *	WS
Category	Earthen Levee			GPS Latitude/Longitude	
				Start	End
Item	Encroachments			38.240012 °	38.240012 °
				-121.522418 °	-121.522418 °
DWR ID	DWR_RD0003_02_f_2018_201				
Comment Code					
TR : Tree or limb					
Inspector Comment					
Remove fallen tree limbs from waterside slope.

View of fallen tree that has been chopped up on the water side slope (October 2018).

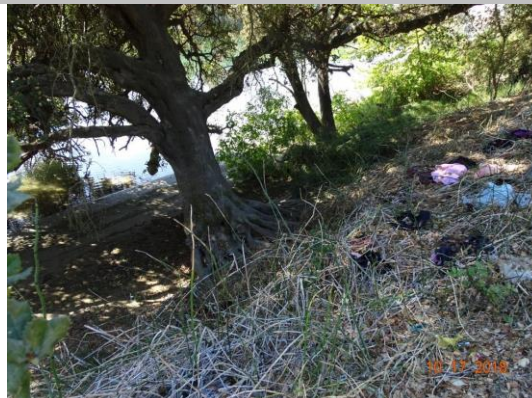
Photo 1 of 3 : FA\_2018\_RD0003\_25\_118\_20181018\_00308.jpg

LM Start	11.33	Rating **	M	Issue No.	118
LM End	11.41	Issue Type +	Ma	Location *	WS
Category	Supplemental			GPS Latitude/Longitude	
				Start	End
Item	2017 USACE Erosion Survey, DRAFT			38.239870 °	38.239992 °
				-121.520989 °	-121.519542 °
DWR ID	DWR_RD0003_02_f_2018_118				
Comment Code					
Inspector Comment					
2017 Site ID: SAC 26.3 R					
Status: Repaired					
2018: Still pocket of erosion into waterside toe.					
2017 Field Notes: Repaired by locals.					
Site History: 2009 - Hole left in levee toe from a fallen tree. Could be repaired under maintenance. 2010 - Minor new erosion. 2015 - Minor new erosion at toe.

View of erosion at the water side toe (October 2018).

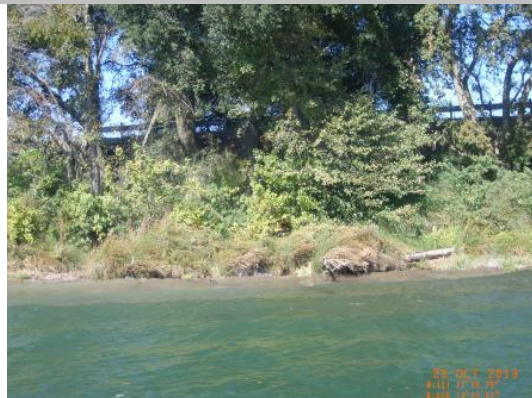
Photo 2 of 3 : FA\_2018\_RD0003\_25\_118\_20181023\_00042.jpg

USACE 2013 Photo #1

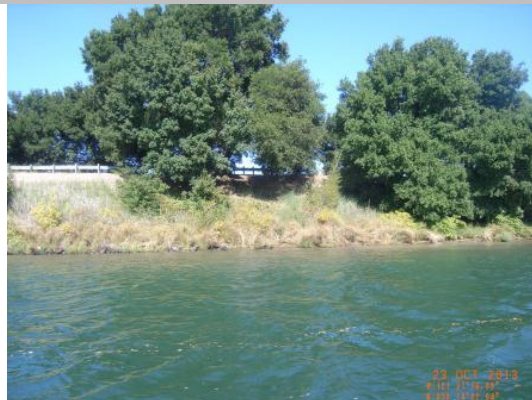
Photo 3 of 3 : FA\_2018\_RD0003\_25\_118\_20181023\_00043.jpg

USACE 2013 Photo #2

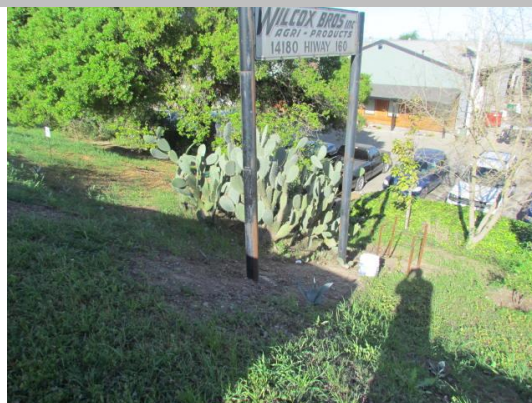
Photo 1 of 1 : FA\_2018\_RD0003\_25\_155\_20180925\_00132.jpg

LM Start	11.58	Rating **	M	Issue No.	155
LM End	11.58	Issue Type +	En	Location *	LS
Category	Earthen Levee			GPS Latitude/Longitude	
				Start	End
Item	Vegetation			38.241412 °	38.241412 °
				-121.517027 °	-121.517027 °
DWR ID	DWR_RD0003_02_s_2015_155				
Comment Code					
V6 : Landscaping					
Inspector Comment					
Cactus on landside slope.

Looking southwest at cactus on landward slope and toe.

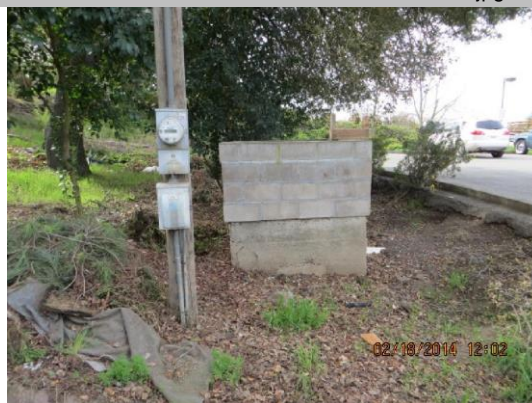
Photo 1 of 3 : UCIP\_FA\_2018\_30363\_55842.jpg

Comment Code						
Inspector Comment						
FS_ID:30363						
DS_ID:22290						
EP_NO: 665						
Repair Type: Non-Urgent						
Crossing Status: Found						
UCIP Comments: Appears abandoned and if so should be done so properly.						
FIELD_STRUCT_DESC: 10-inch steel irrigation discharge pipe through the levee, invert elevation 2.8 feet below the crown. Pump on a pile structure in the river. 5-foot by 5-foot concrete distribution box at the landside (LS) toe with a meter pole. (Plans for the installation of a 10-inch, 10-gauge discharge pipe through the levee Permit No. 665, 1936 - C. T. Vollman). [Additional Reference(s): DWR Levee Log, 1993. USACE Sacramento O&M Manual 104, February 1960, (RM 26.62)].						
FS Date: 2/18/2014

Concrete distribution box and meter on pole on LS toe.

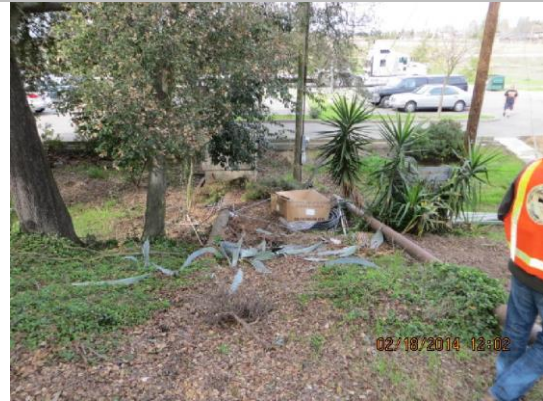
Photo 2 of 3 : UCIP\_FA\_2018\_30363\_55841.jpg

Pipe and distro box visible at left side of photo.

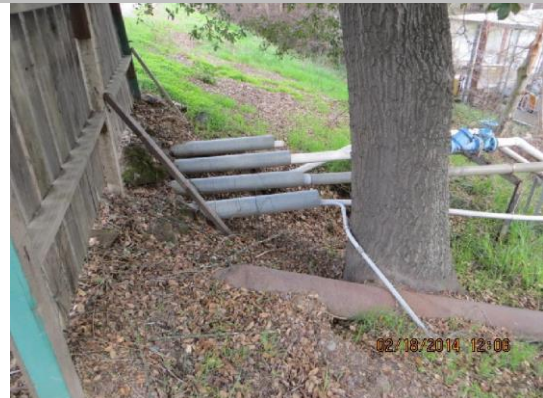
Photo 3 of 3 : UCIP\_FA\_2018\_30363\_55840.jpg

Pipe visible in foreground next to oak.

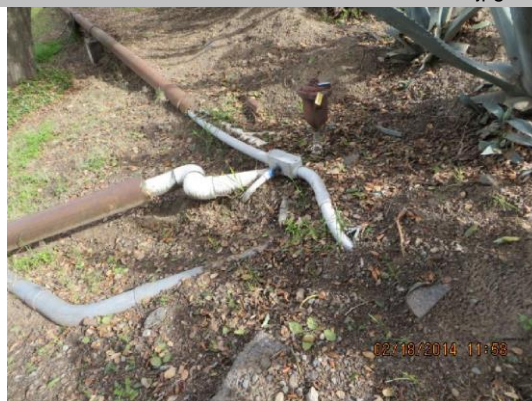
Photo 1 of 2 : UCIP\_FA\_2018\_30352\_55824.jpg

Electrical conduit visible on LS slope.

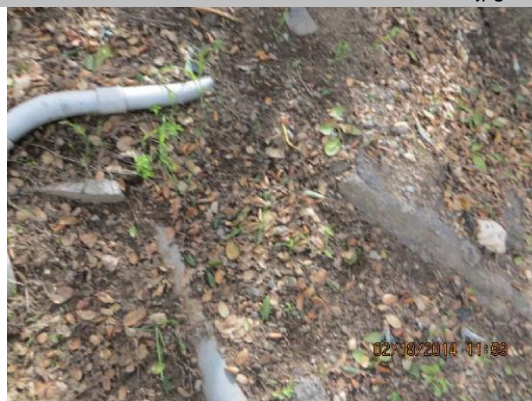
Photo 1 of 3 : UCIP\_FA\_2018\_30353\_55827.jpg

Electrical conduit visible on LS slope.

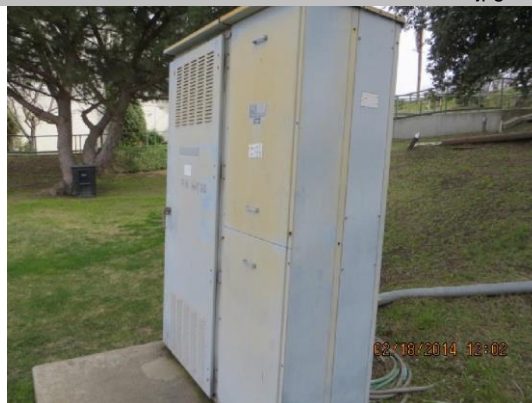
Photo 2 of 3 : UCIP\_FA\_2018\_30353\_55826.jpg

Electrical panel visible on LS toe.
